MAG AR200U

IMPORTANT NOTICE

(based on CP3)

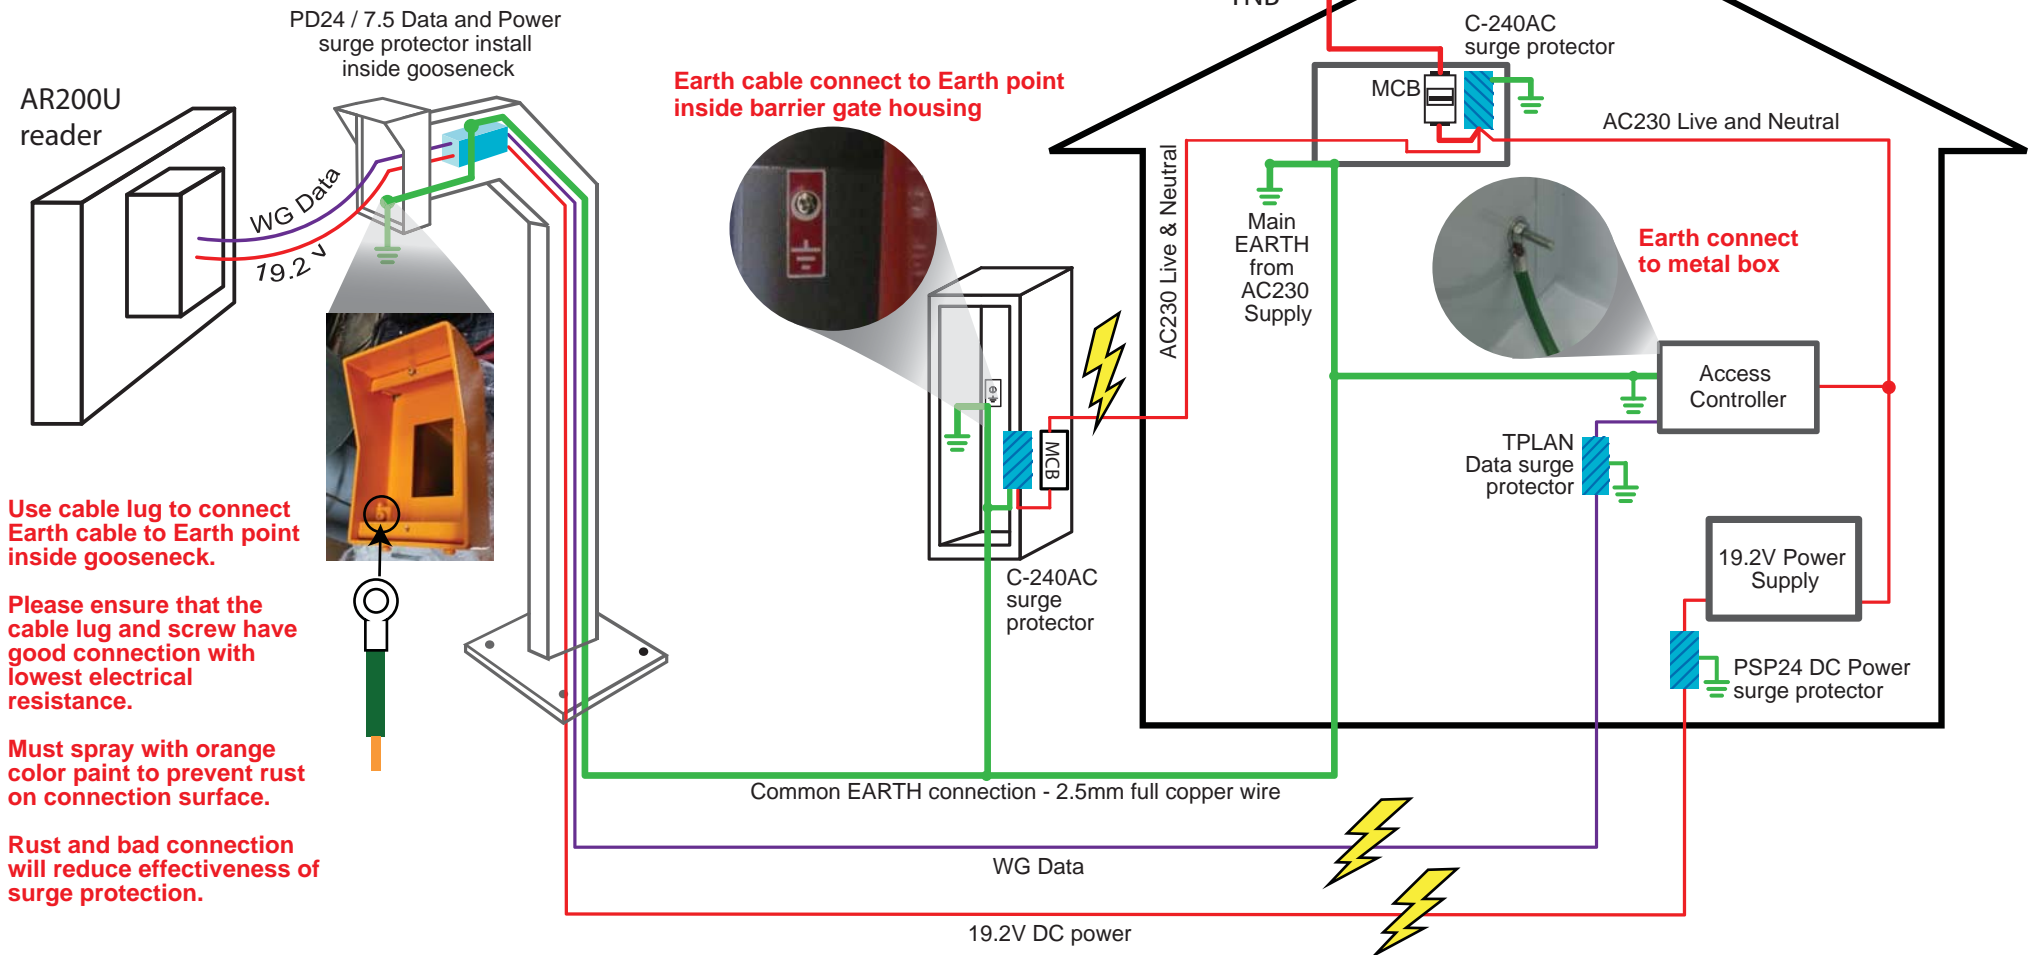
Important step to implement correct surge protection for AR200U

- 1 All metal body of gooseneck, barrier gate, access controller MUST be connect to AC EARTH at guard house.
- 2 Must install surge protector with proper EARTH connection to guard house.
- 3 EARTH wire must use at least 2.5mm full copper wire.

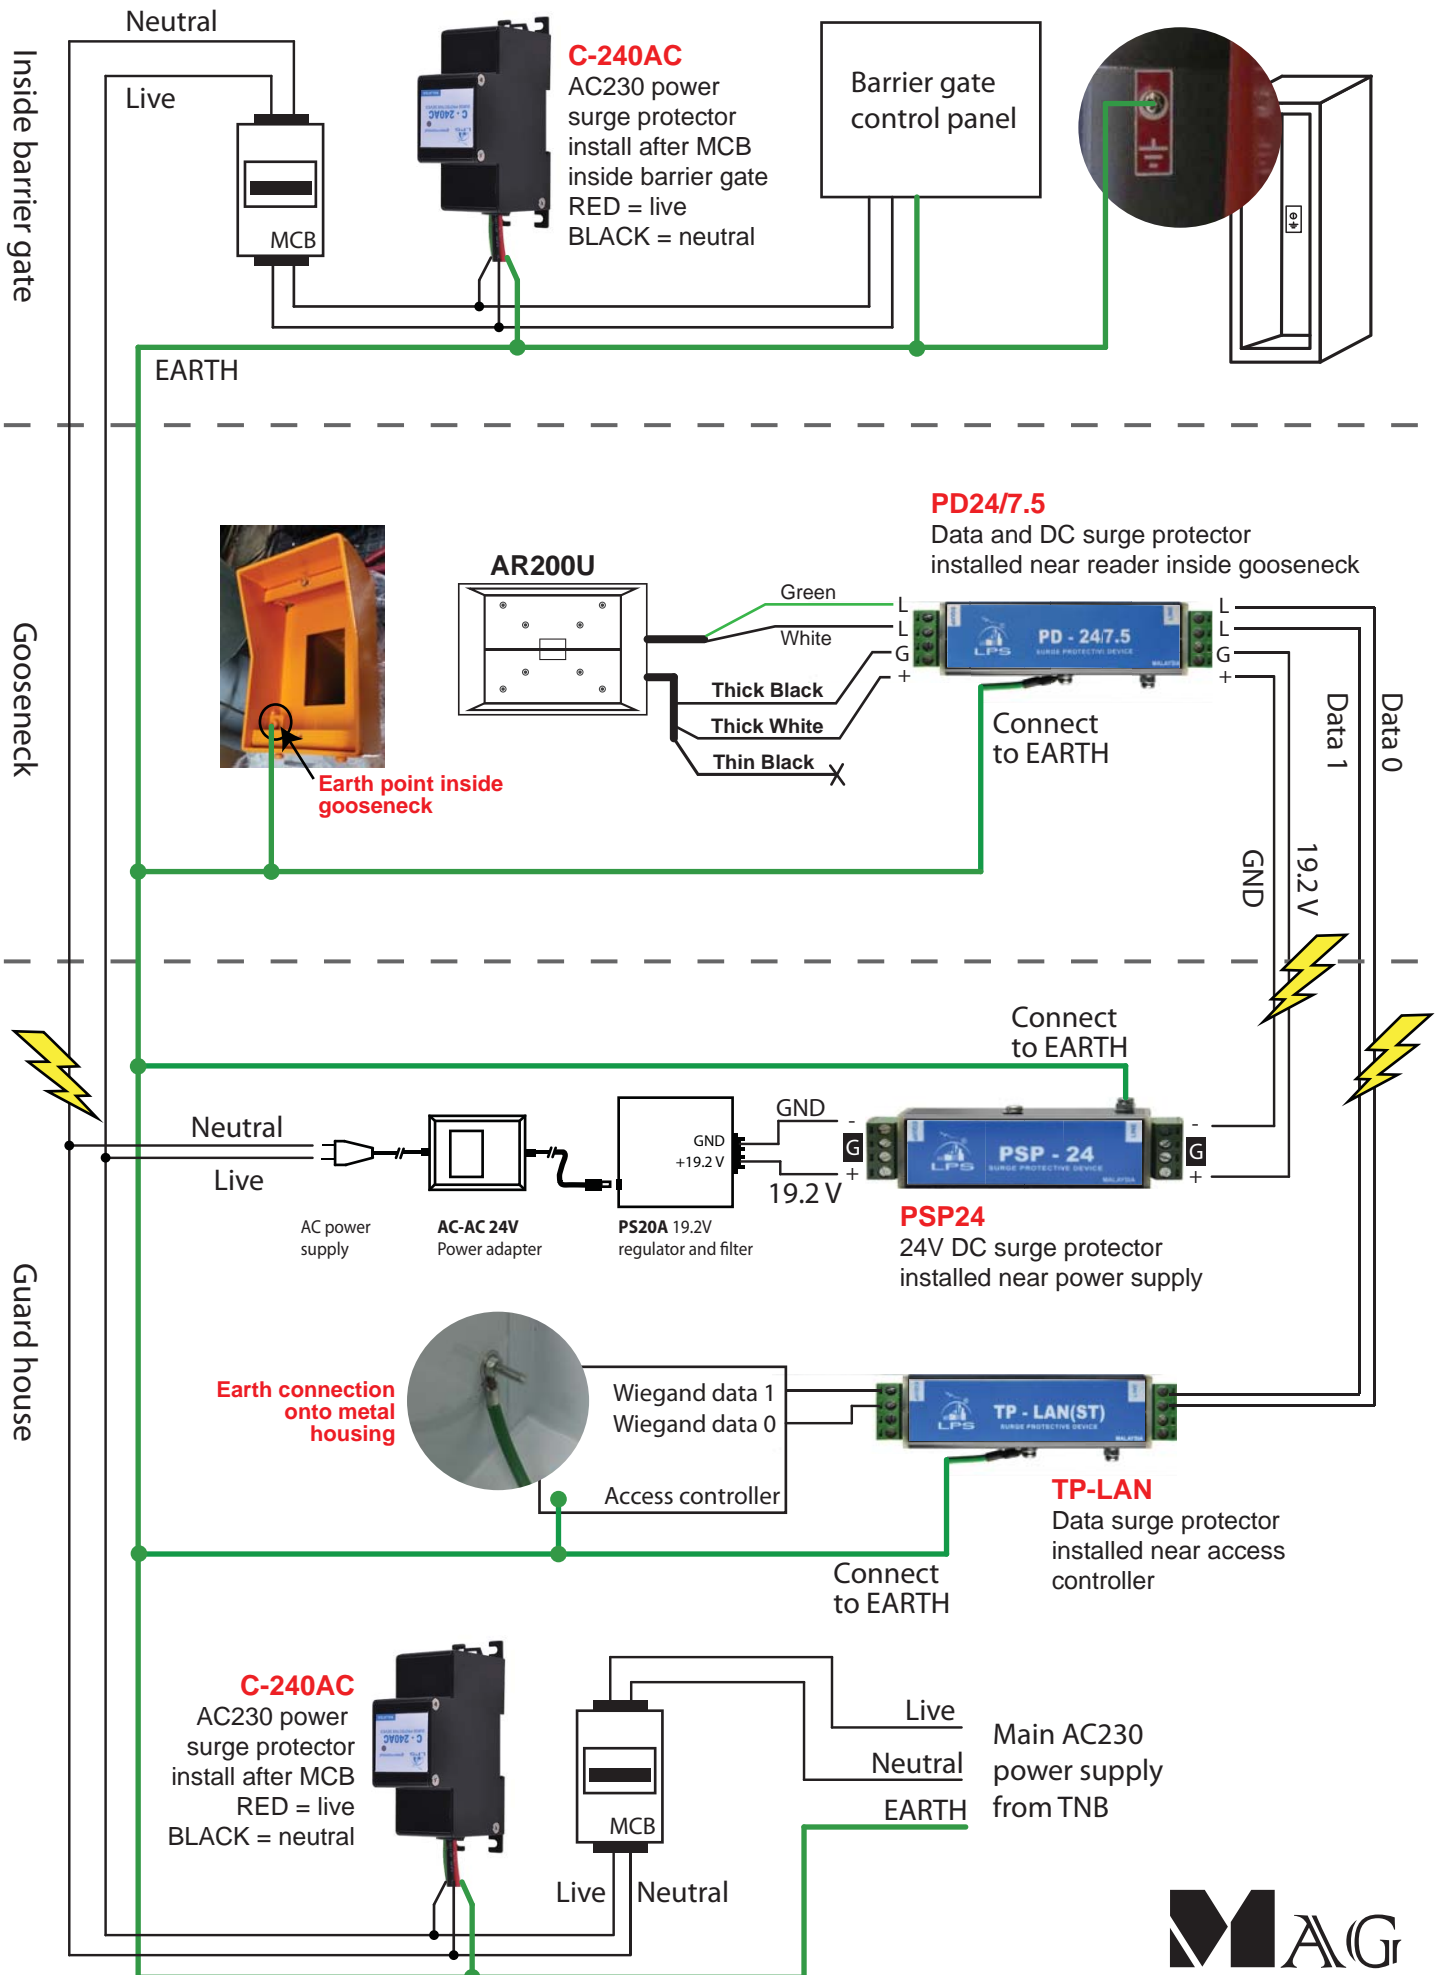
EARTH AND SURGE PROTECTION CONNECTION DIAGRAM FOR AR200U (based on CP3)
